ARMY RESEARCH LABORATORY

# Investigation of Corrosion on Inland Petroleum Distribution System Aluminum Pipe Grooved Ends Caused by Rubber Gaskets

ARL-TR-1449

August 1997

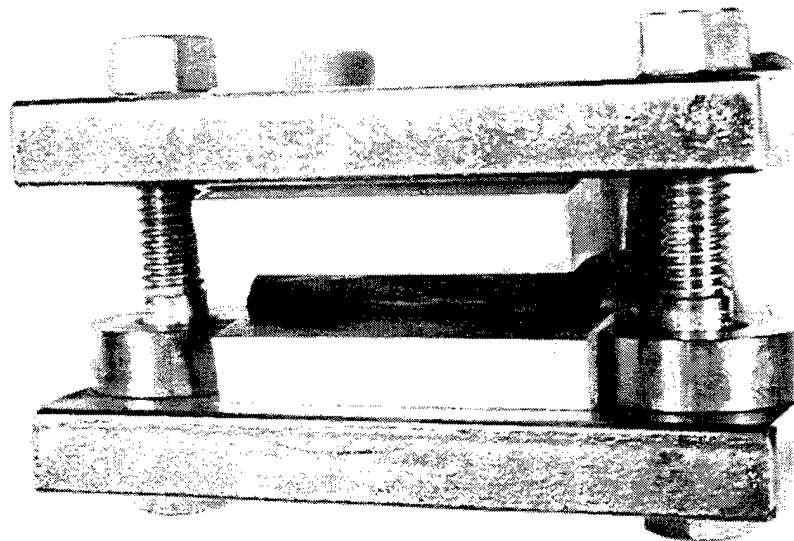
Figure 3. View of the cross-sectional rubber specimen placed between two small, curved aluminum pipe pieces in the stainless steel clamp for the accelerated corrosion test (actual size). This setup would simulate the rubber gasket in compression inside the IPDS snap-joint coupling in the clamped position. The compressed seal lips of the gasket is in contact with the bare surface of the curved IPDS pipe pieces.

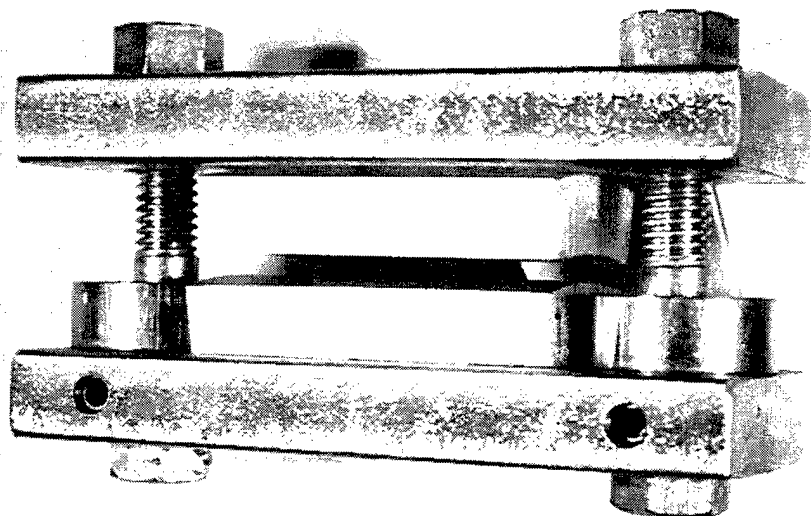
Figure 4. View of the flat rubber specimen placed between two small, curved aluminum pipe pieces in the stainless steel clamp for the accelerated corrosion test (actual size). The specimen is in contact with both bare aluminum surfaces.
